EFFLORESCENCE & NEW BUILDING BLOOM

**International
Masonry Institute**

Efflorescence and New Building Bloom Tip

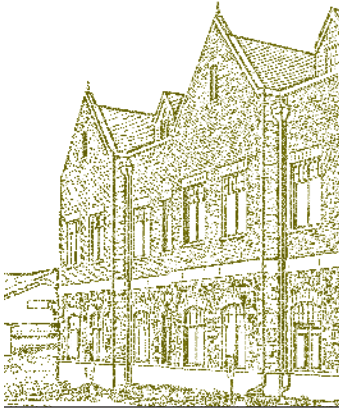
During construction, water gets inside a wall system and causes initial efflorescence, or “new building bloom.” Remain calm: the wall will dry and the efflorescence will go away.
